Manhole Inspection Summary

Manhole # S35G__014MH

Insp Date: **8/12/08 1:52 PM**

Location Address: **30 calvert st**

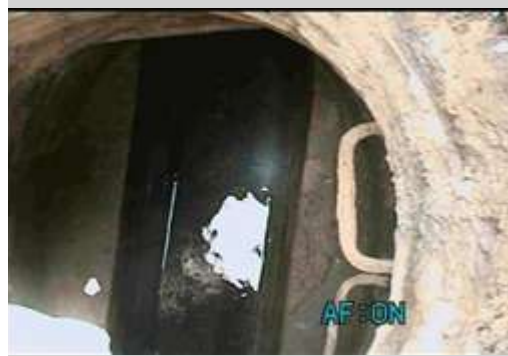
Top View

Top view & steps

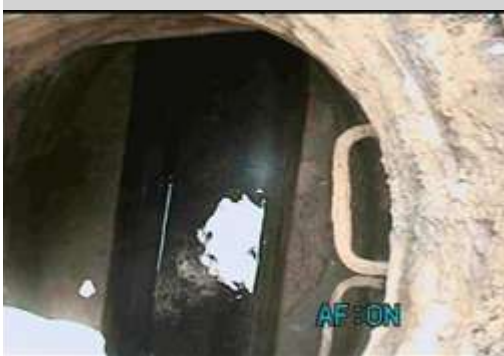
Defect 3

Steps Count: **2** Missing: **0** ☒ **Corroded**

Steps corroded

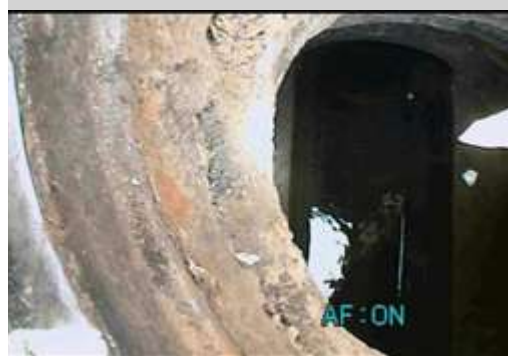
Defect 2

Frame Offset: **2** (in.) Condition: ☒ Sound ☐ Cracked ☐ Leaks

offset

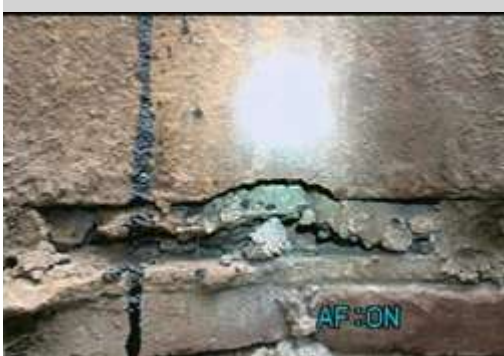
Defect 1

Condition: ☐ Sound ☐ Cracked ☐ Root Intrusion ☒ **Loose Brick** ☐ Deteriorated

loose bricks, frame adj

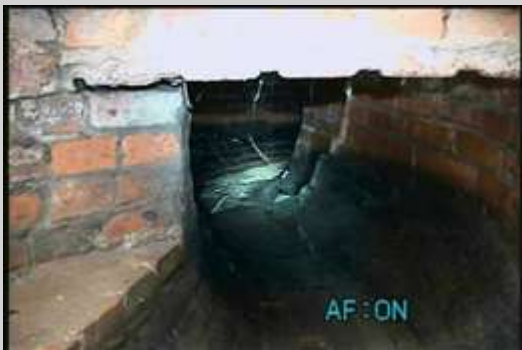
12 O'Clock Outflow

24 in. Circular Gravity Sewer
Pipe Out @ 12 O'Clock

Pipe Material: **Clay** ☐ Pipe Lined

Invert Depth: **6.33** (ft.) Flow Characteristics: **Fast**

Infiltration: **None** Pipe Seal Cond: **Unknown**

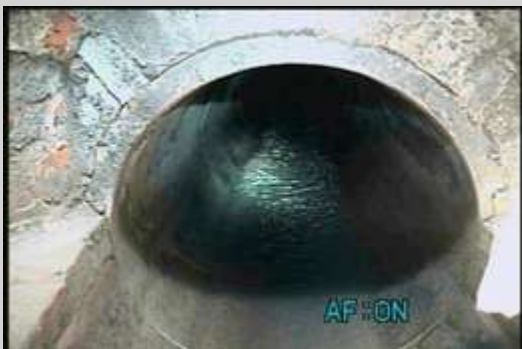
6 O'Clock Inflow

15 in. Circular Gravity Sewer
Pipe In @ 6 O'Clock

Pipe Material: **Clay** ☐ Pipe Lined

Invert Depth: **6.30** (ft.) Flow Characteristics: **Fast**

Infiltration: **None** Pipe Seal Cond: **Unknown**
